## ABOUT MOUNT RUSHMORE

**Industry:** Civil

**Location:** Keystone, South Dakota

# Mount Rushmore RBMS

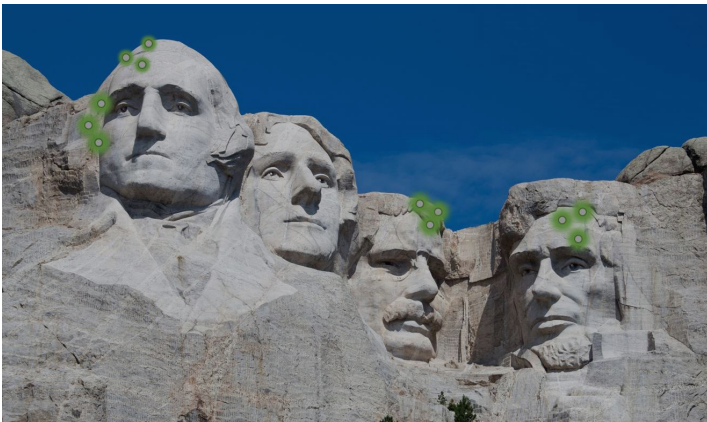
Luna sensors monitor four separate regions on the monument for strain and temperature

Luna, along with partner Respec, developed a Rock Block Monitoring System (RBMS) using one sm125 HYPERION Optical Sensing Interrogator, 24 os3110 Optical Strain Gages, and 12 os4310 Non-metallic Temperature sensors. This system will help improve data quality and reliability, while reducing maintenance cost by replacing the existing RBMS. Four locations will be monitored on the mountain – two on Washington, one on Roosevelt, and one on Lincoln. Absolute temperature measurements will be made at each of the locations with an os4310 temperature sensor.

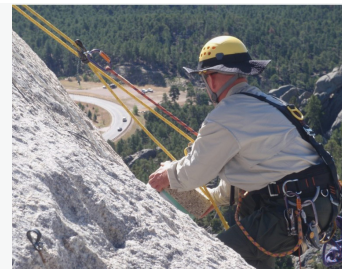
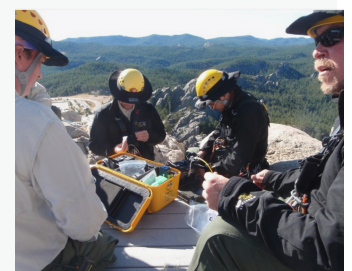
The National Park Rope Access Team roped off to perform installations
